Subject: Submittal of the 2018 Monitoring Report for Los Alamos/Pueblo Watershed
Sediment Transport Mitigation Project

1. Two hard copies with electronic files – 2018 Monitoring Report for Los Alamos/Pueblo Watershed Sediment Transport Mitigation Project (EM2019-0106)

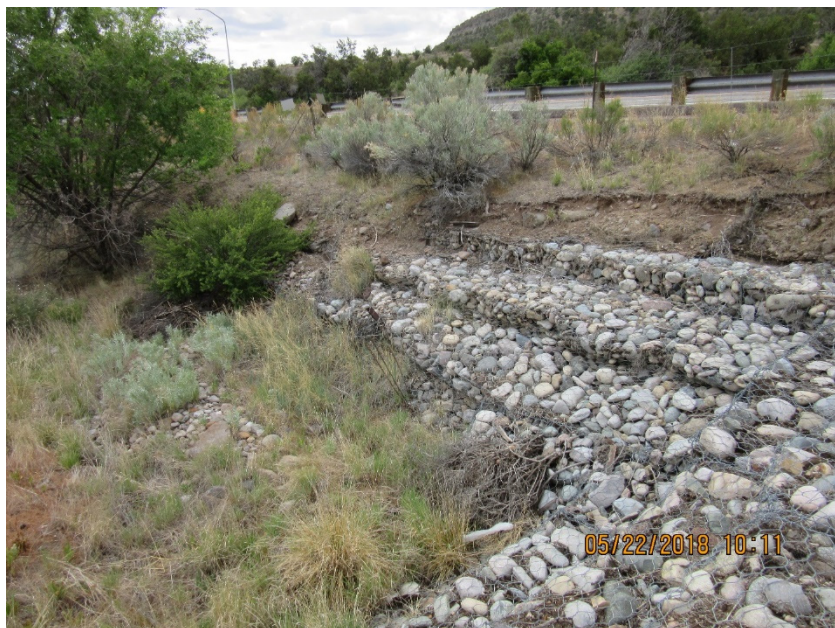
Photo B-4.3-1 May 2018—Downstream southern embankment slope. No erosion or sloughing of gabion baskets occurring. All gabion baskets appear to be structurally intact and operating as designed. Wet from recent rain event.

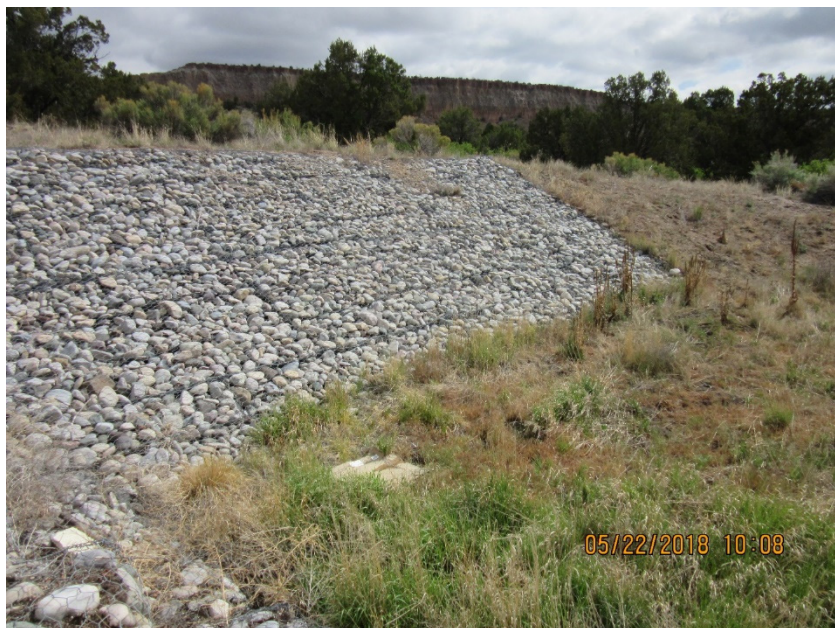
Photo B-4.3-2 May 2018—Downstream northern embankment slope. No erosion or sloughing of gabion baskets occurring. All gabion baskets appear to be structurally intact and operating as designed. Wet from recent rain event.

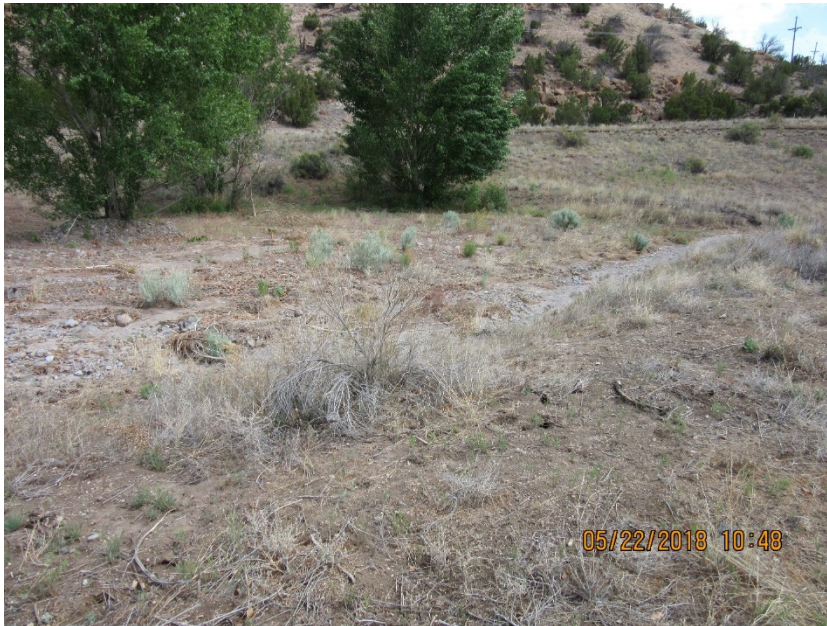
B-4.4 Upper Pond

Photo B-4.4-1 May 2018—Los Alamos Pond 1 (upper) looking downstream east. Pond has no capacity to retain sediment.

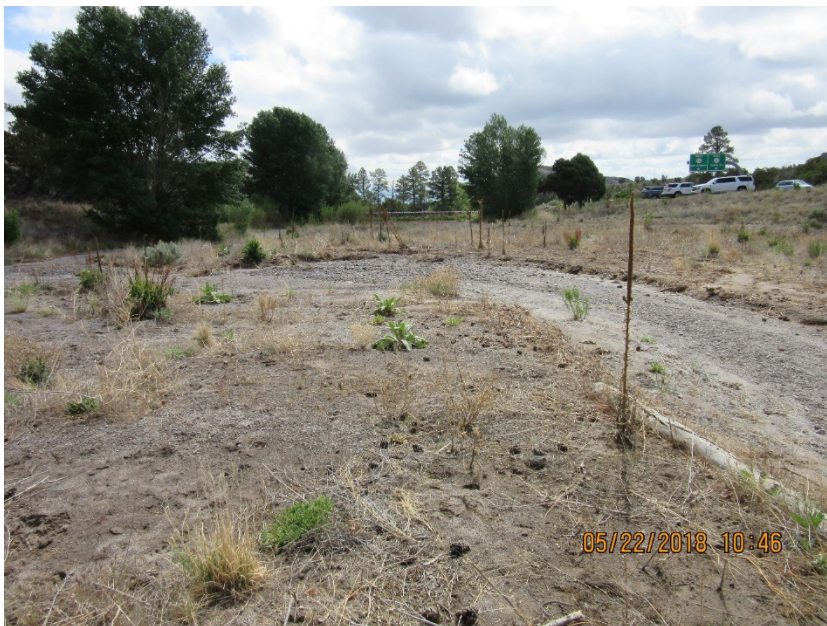
B-4.5 Middle Pond

Photo B-4.5-1 May 2018—Los Alamos Pond 2 (middle) looking downstream. The pond has no capacity to retain sediment.

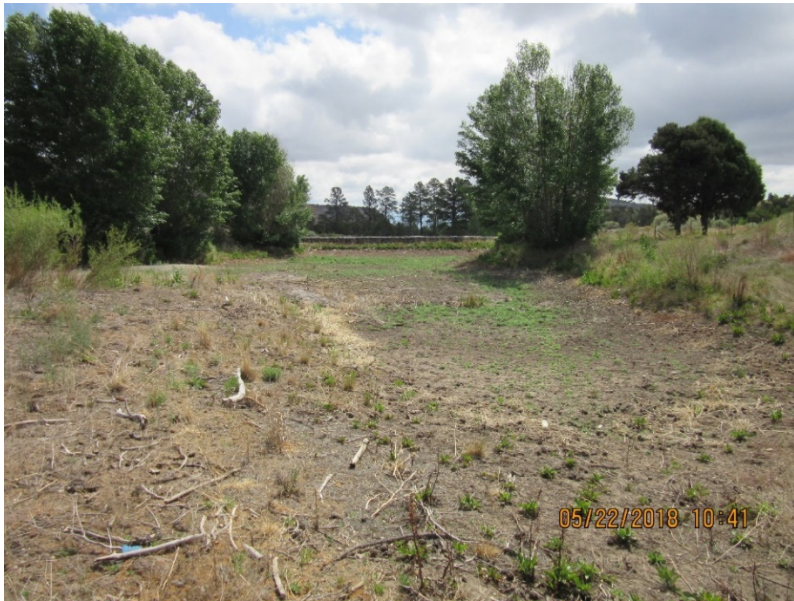
B-4.6 Lower Pond

Photo B-4.6-1 May 2018—Los Alamos Pond 3 (lower) looking downstream. Approximately 8 ft of freeboard from bottom of pond to weir crest.

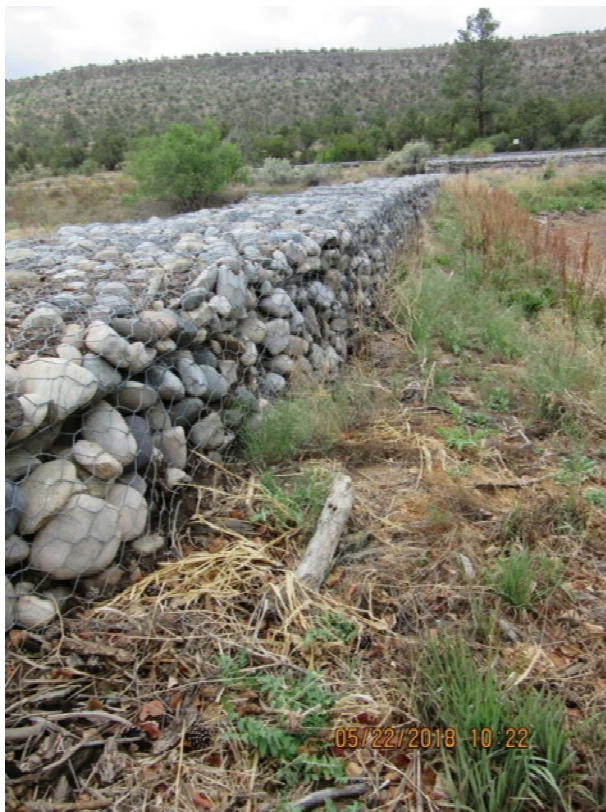
B-4.7 Upslope Face and Crest of Overflow Weir Structure

Photo B-4.7-1 May 2018—Upstream weir face. Continue to monitor bulging gabion baskets.

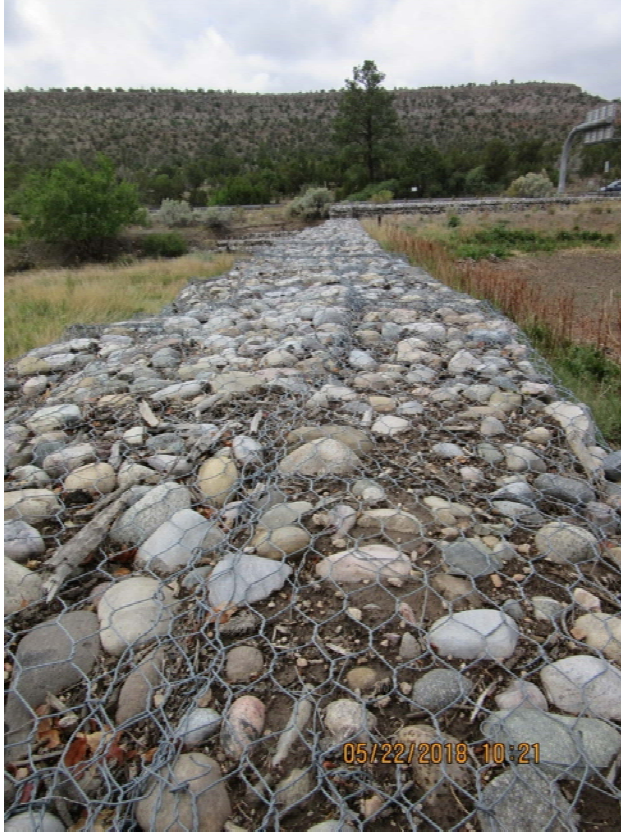
Photo B-4.7-2 May 2018—Weir crest. Continue to monitor broken gabion wires on weir crest for need of preventative maintenance.

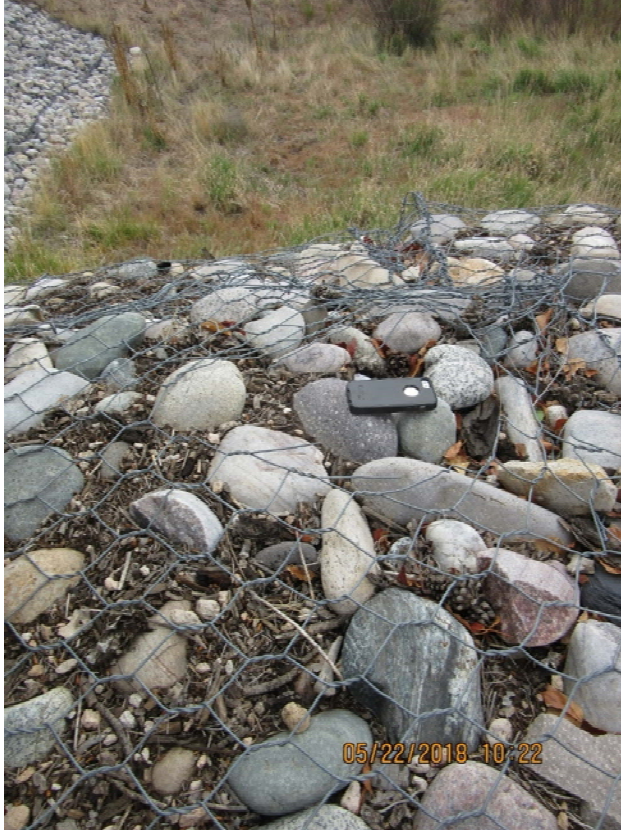
Photo B-4.7-3 May 2018—Broken gabion wires on north end of weir crest. Continue to monitor broken gabion wires on weir crest for need of preventative maintenance.

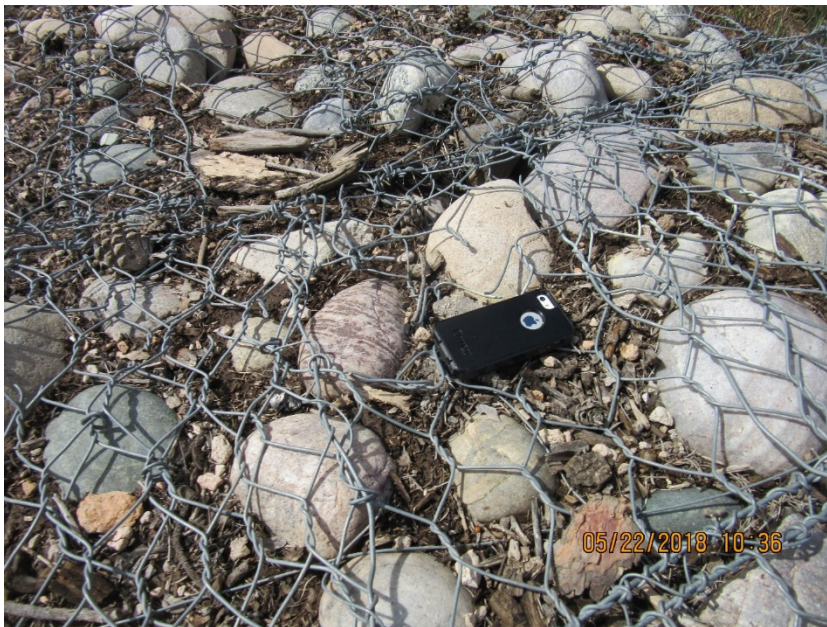
Photo B-4.7-4 May 2018—Broken gabions on south end of crest. Continue to monitor broken gabion wires on weir crest for need of preventative maintenance.

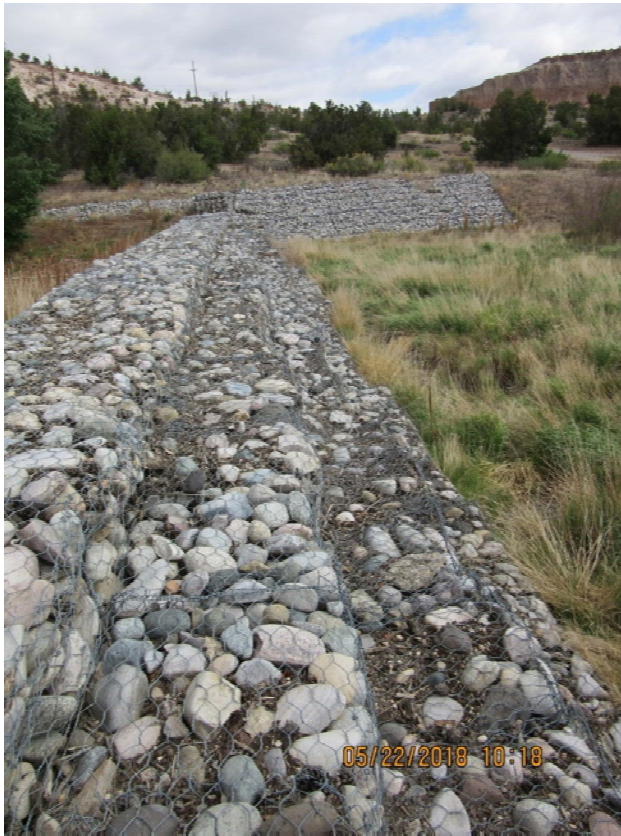
Photo B-4.8-1 May 2018—Downstream weir face. Continue to monitor bulging baskets and joints.

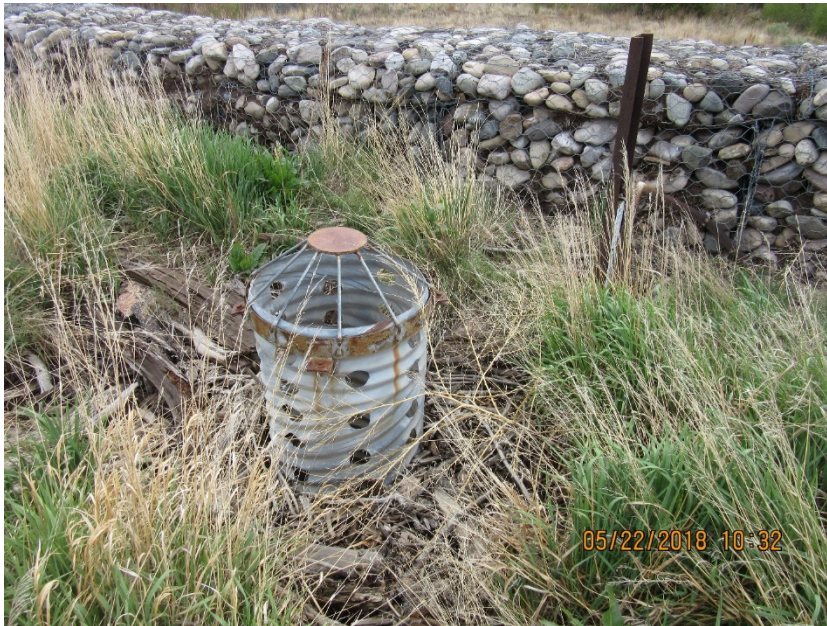
B-4.9 Weir Standpipe

Photo B-4.9-1 May 2018—Standpipe. Gage reads approximately 5.5 ft of sediment and debris. Approximately 3 ft of standpipe exposed no change from previous inspection. Inlet is clear of debris and functioning correctly.

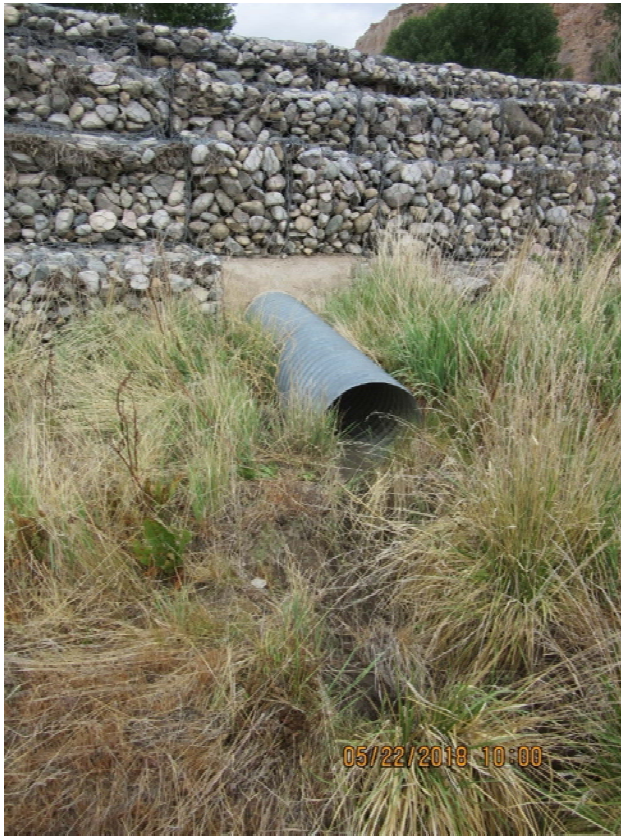
B-4.10 Weir Outlet

Photo B-4.10-1 May 2018—Weir outlet. Outlet is stable with no evidence of piping or undercutting. Outlet is functional and not impeded by sediment, trash, or debris. Continue to monitor channelization occurring from outlet to channel.

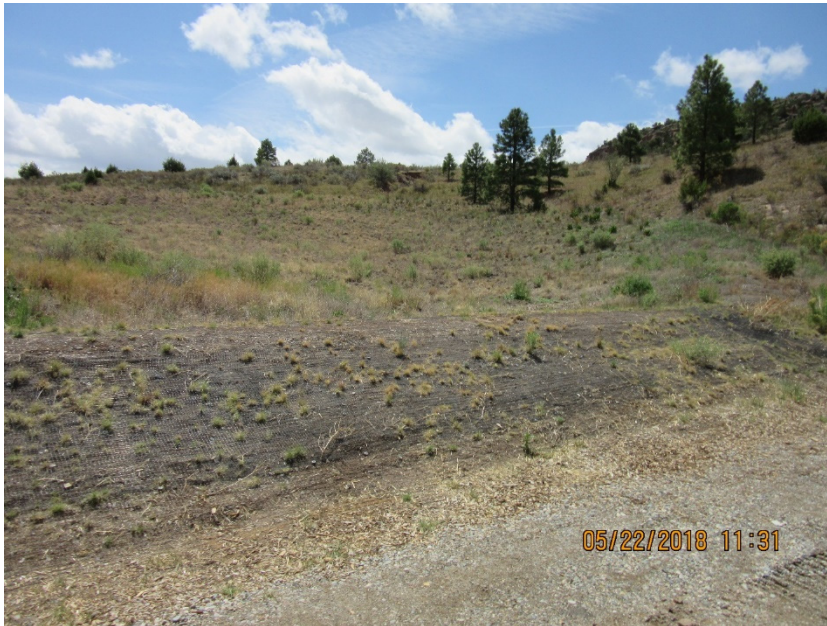
Photo B-4.11-1 May 2018—Borrow pit and berm. Construction debris are present from Los Alamos County construction project. Continue to monitor and determine timing for repair to torn TRM on berm after cessation of Los Alamos County construction project. Continue to monitor rodent burrows.

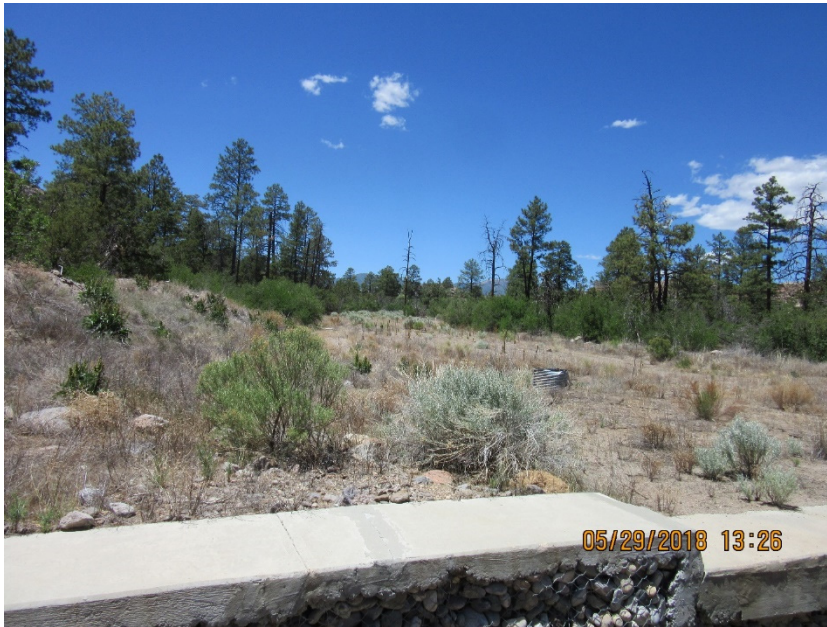
B-5.1 Upstream Embankment

Photo B-5.1-1 May 2018—South embankment, looking west. Well-established vegetation on embankment. No signs of erosion or undermining.

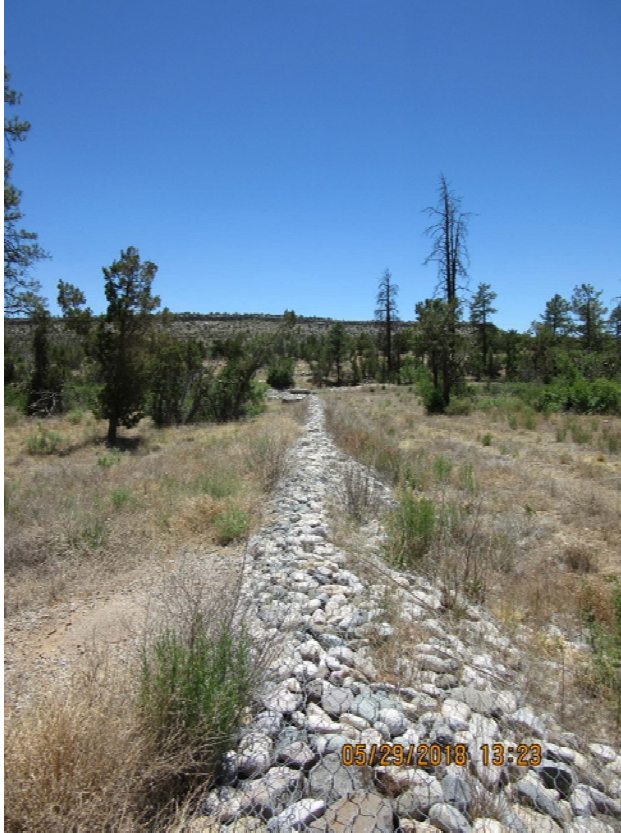
B-5.2 Embankment Abutment

Photo B-5.2-1 May 2018—Embankment abutment from north side of channel, looking south. Well-established vegetation surrounding control. No presence of trash/debris.

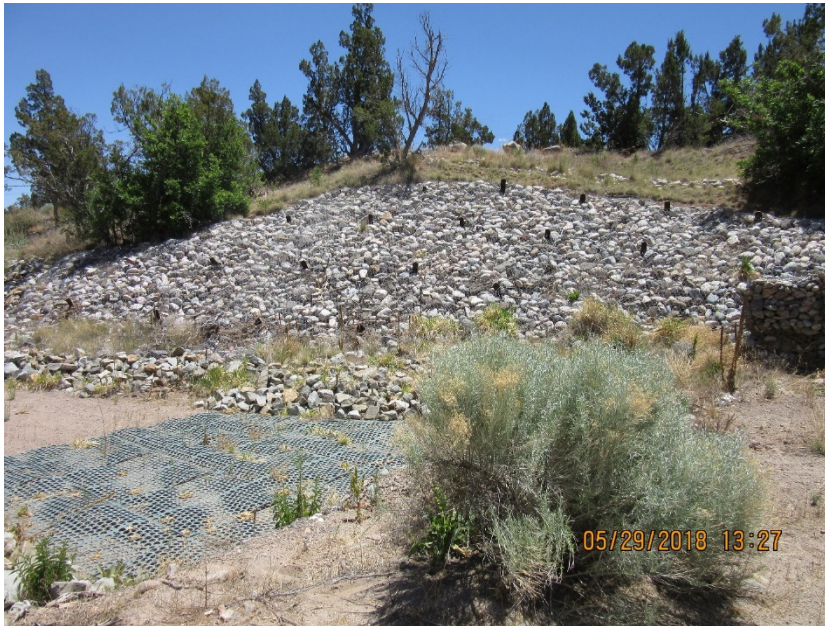
B-5.3 Downstream Embankment and Outlet

Photo B-5.3-1 May 2018— Downstream south embankment and scour-stop, looking south. Control is operating as designed. No buckling of embankment occurring. Riprap functioning as designed. Vegetation established and no evidence of erosion. Some scour-stop is buckling but is still anchored; continue to monitor.

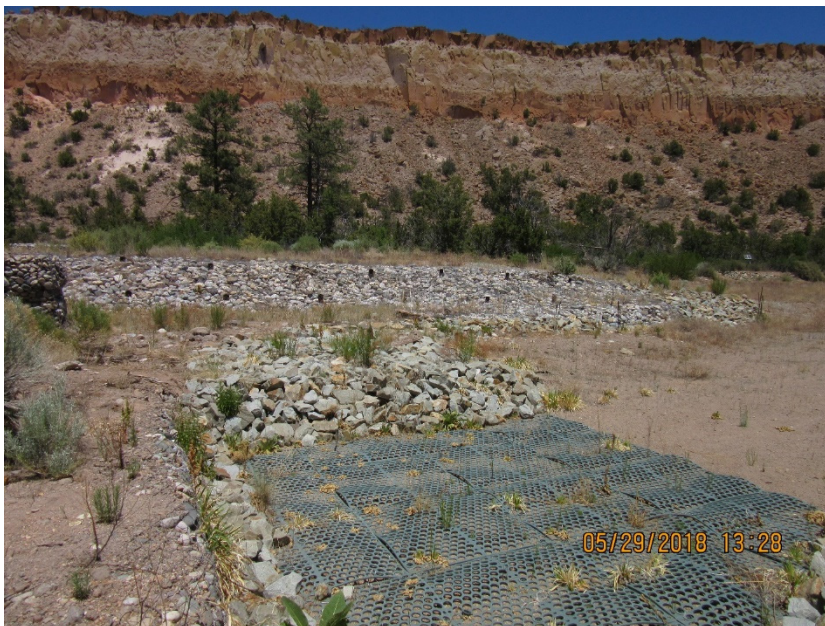
Photo B-5.3-2 May 2018—Downstream north embankment and scour-stop, looking north. Control is operating as designed. No buckling of embankment occurring. Riprap functioning as designed. Vegetation established and no evidence of erosion. Approximately 4 in. of culvert is revealed. Some scour-stop is buckling but is still anchored; continue to monitor.

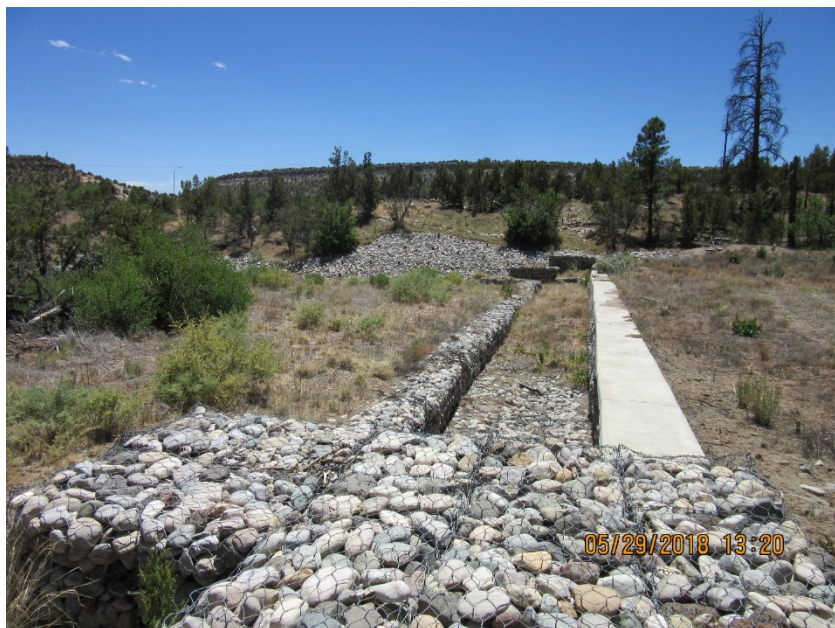
Photo B-5.4-1 May 2018—Weir crest and flow-way, looking south. Sediment has filled in to top of spillway upstream of the structure. No cracks present in concrete. Structure is in alignment and functioning as designed. Continue to monitor bulging basket at north end of weir.

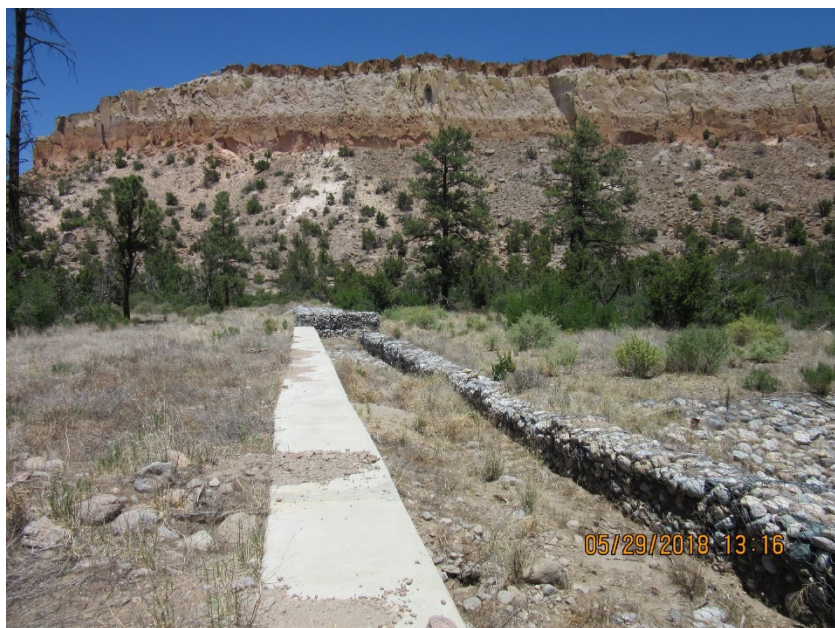
Photo B-5.4-2 May 2018—Weir crest and flow-way, looking north. Sediment has filled in to top of spillway upstream of the structure. No cracks present in concrete. Structure is in alignment and functioning as designed. Continue to monitor deteriorating joint on north flow-way edge and bulging gabion basket at north end of weir.

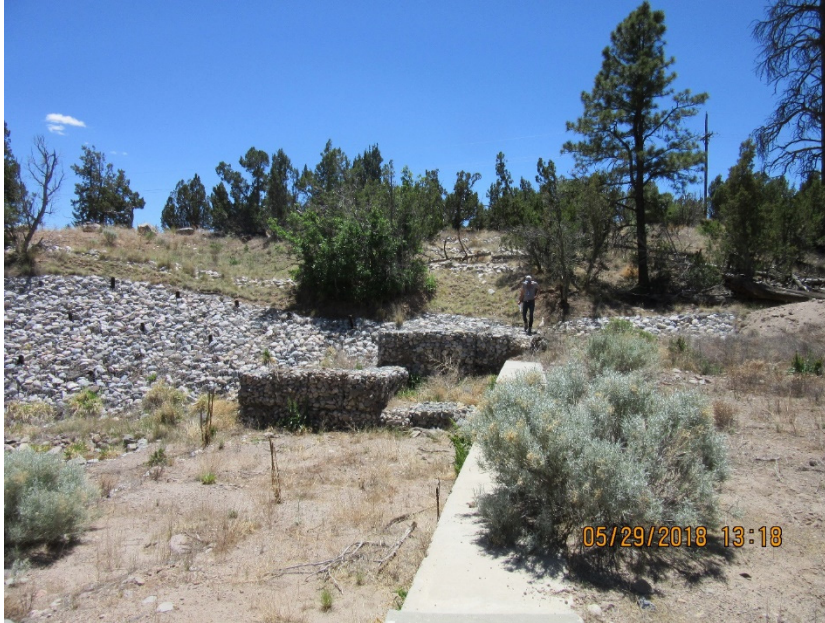
Photo B-5.4-3 May 2018—Weir spillway and flow-way, looking south. Sediment has filled in to top of spillway upstream of the structure. No cracks present in concrete. Structure is in alignment and functioning as designed. Continue to monitor deteriorating joint on north flow-way edge and bulging gabion basket at north end of weir.

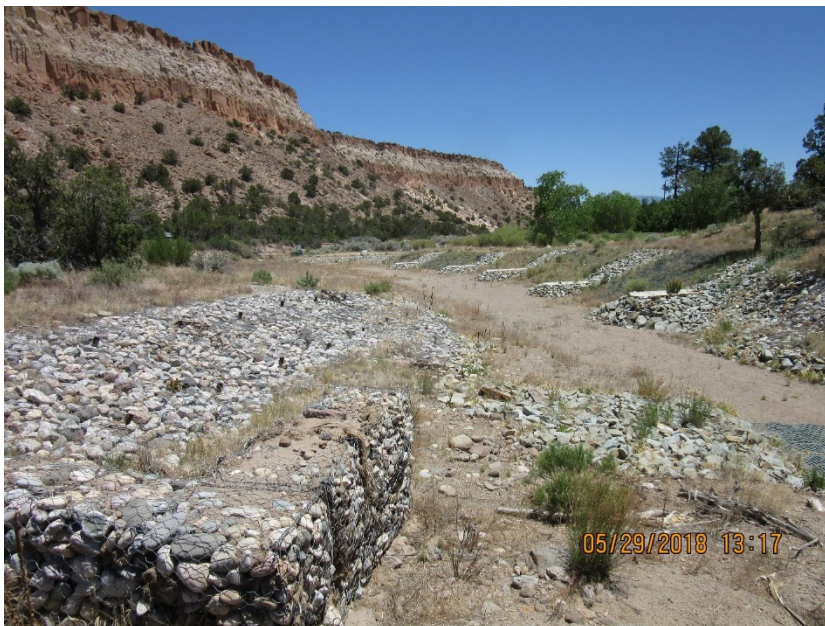
Photo B-5.5-1 May 2018—Redi-rock spurs, looking east. Well-established vegetation along all hillslopes. No erosion apparent along slopes or near TRM. All structures functioning as designed.

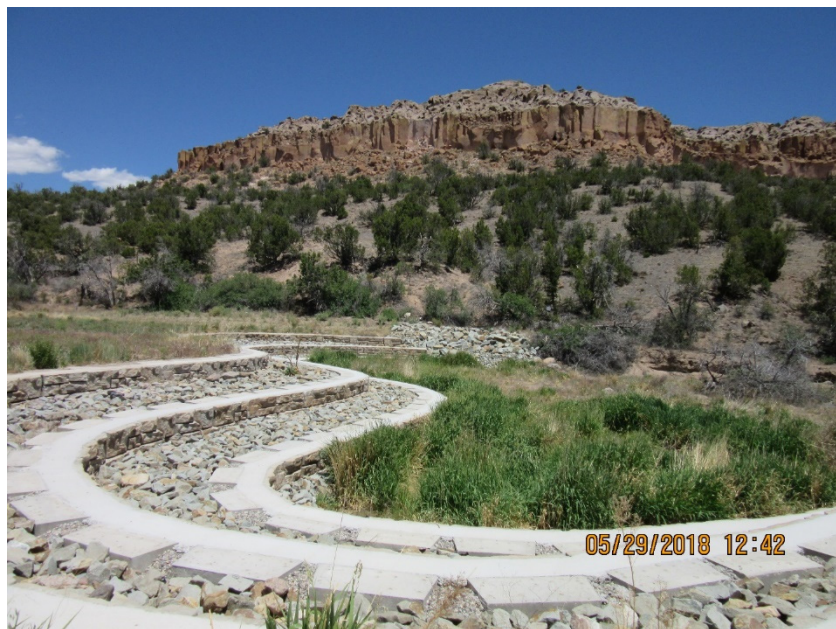
Photo B-6.1-1 May 2018—Redi-rock block structure, looking north. Redi-rock structure shows no evidence of displacement or settling, no noted erosion. Continue to monitor grass transplanted in 2017.

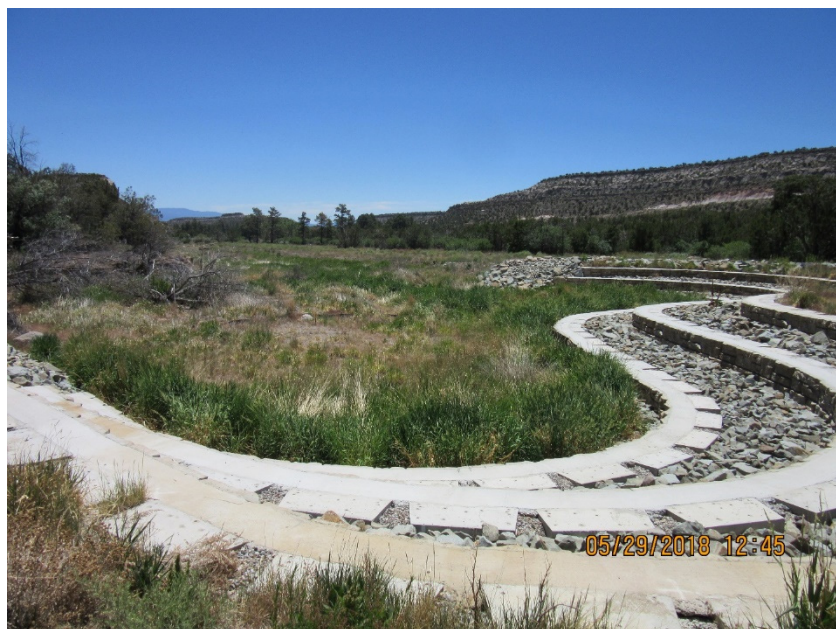
Photo B-6.1-2 May 2018—Redi-rock block structure, looking southeast. Redi-rock structure shows no evidence of displacement or settling, no noted erosion. Continue to monitor grass transplanted in 2017.

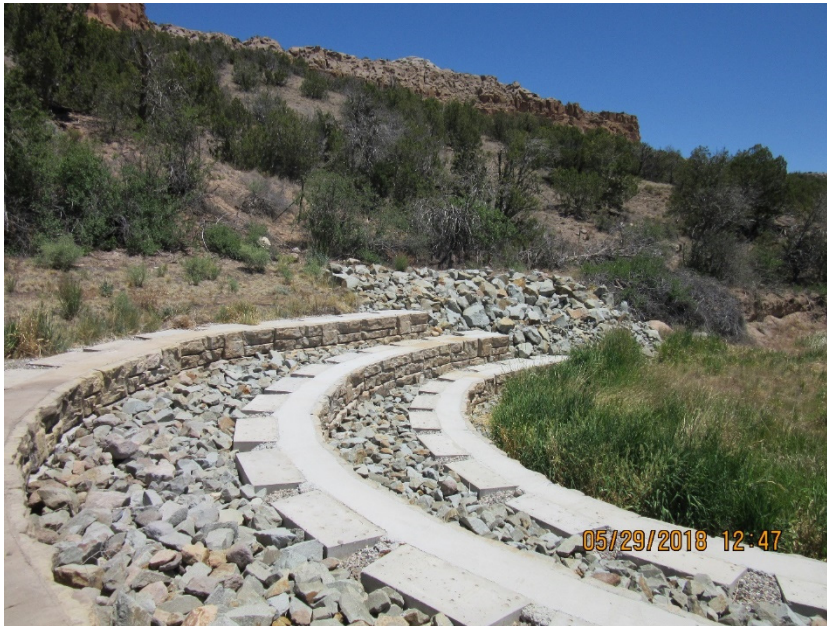
Photo B-6.2-1 May 2018—Wetland north bank, looking northeast. Slope is stable with no evidence of erosion where riprap is located. Structure is functioning as designed with established vegetation.

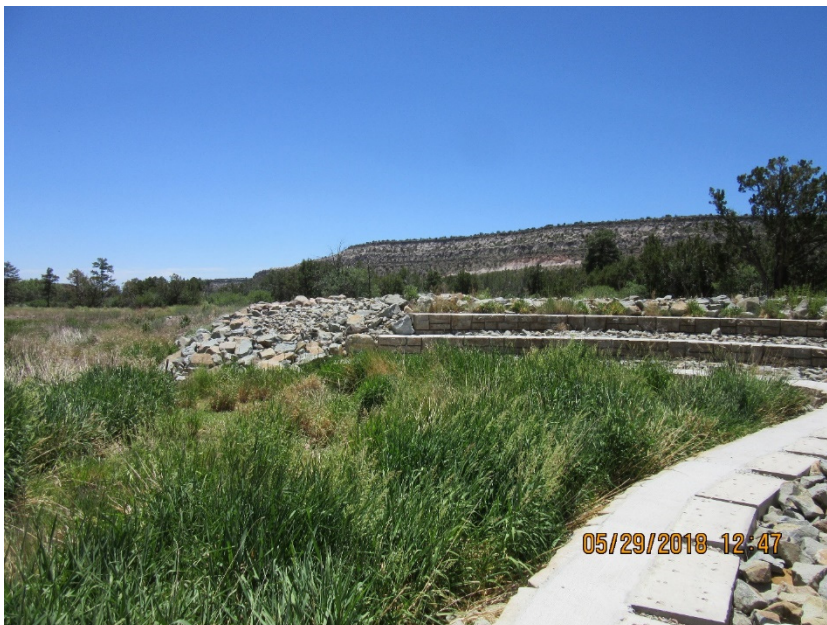
B-6.3 Wetland South Bank

Photo B-6.3-1 May 2018—South bank, looking southeast. Slope is stable no evidence of erosion where riprap is located. Structure is functioning as designed with established vegetation.

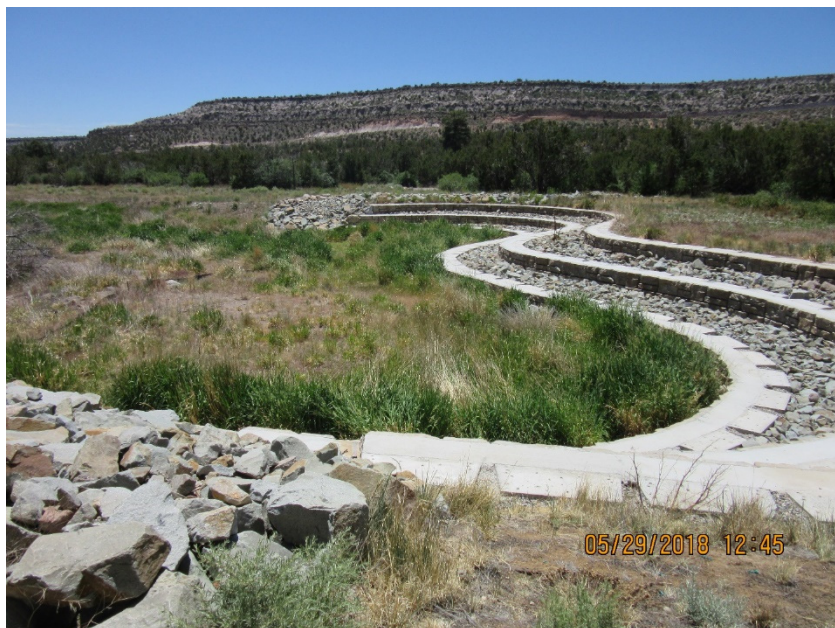
Photo B-6.4-1 May 2018—Redi-rock structure and berm, looking south. Berm is stable no noted erosion or breaching/slides/cracks to berm.

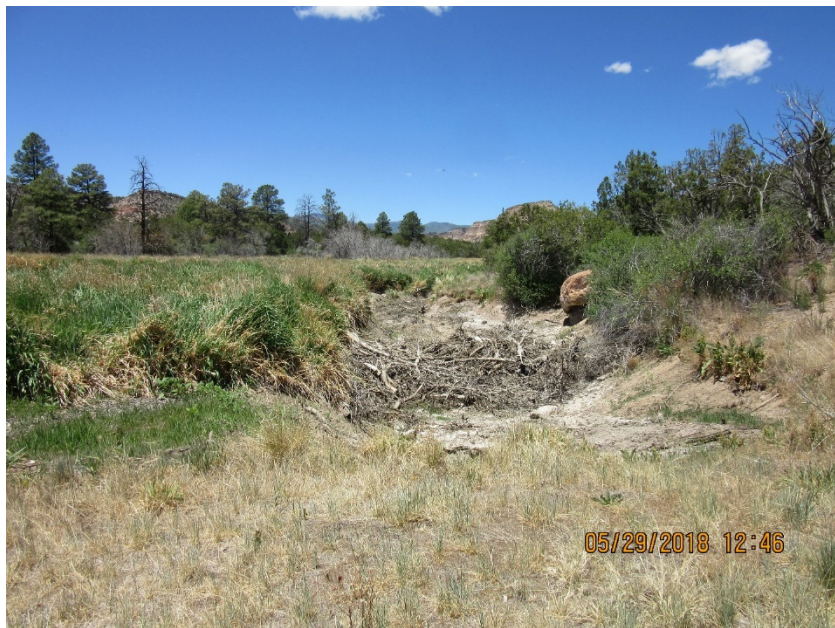
B-6.5 Upstream Area of Wetland

Photo B-6.5-1 May 2018—Upstream pond, looking upstream. TRM at pond is not visible. The pond is approximately 3–4 ft deep. Branches have been placed in pond.
